1 SURREY STREET, BASSENDEAN

Pensioner Guard Cottage (1856-1857, 1991-1993)

Residence (c.1893, c.1952)

CONSERVATION MANAGEMENT PLAN

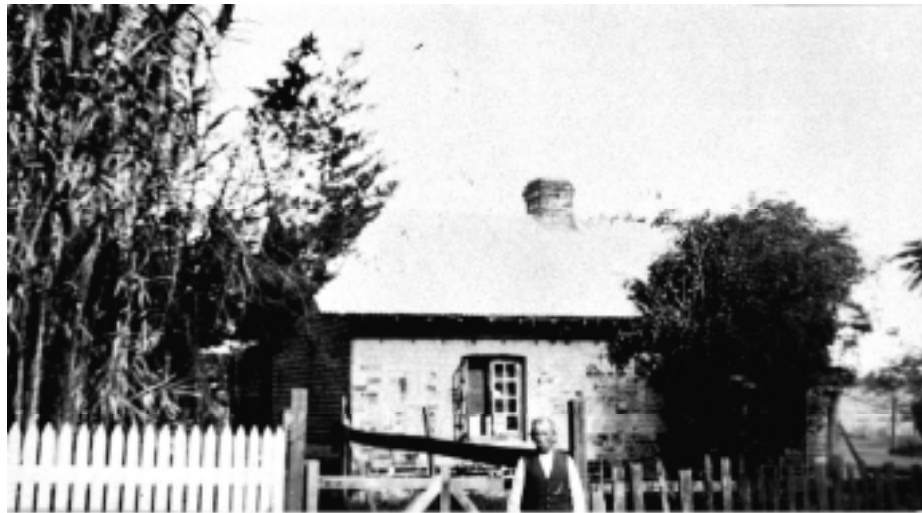
FIGURE 1 (n.d)

Pensioner Cottage, Lot 114. Courtesy Baltye Library 24672P

- Condition The pressed metal ceiling is in fair condition with some evidence of rust.
- Windows The window and door openings have timber lintels. The windows are 1991-1993 replacement timber framed casement windows. Figure 1 shows the original 8 paned double casement windows.

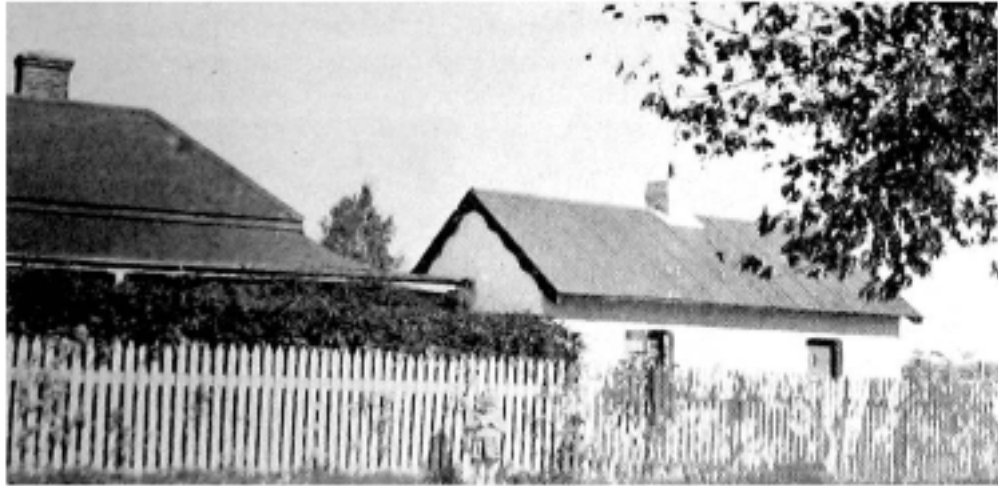
FIGURE 3 Pensioner Guard Cottage showing the c.1893 residence (left)

Pensioner Cottage Lot 114, 1947, with later residence added 1893-1900s.
From Alf Thomas, *History of Bassendean*, 1947, p. 13.

- Inspect the tile roof. Secure the roof and replace any tiles (residence).
- Inspect the waterproof membrane (c.1952 addition to residence) and undertake remedial or replacement works as required.
- Inspect the entire roof drainage system and undertake remedial or replacement works as required.
- Restore the chimneys.
- Should the existing tile roof be found to be inadequate, take the opportunity to reinstall the separate verandah roof and re-clad the existing timber framed roof over the c.1893 residence, and the verandah, with short sheets of galvanised iron cladding.
- Should the roof be re-clad, the entire verandah should be restructured with reference to historic evidence (Figure 3), to ensure an aesthetic per original, although differing in the detail.

The c.1952 additions to the c.1893 residence had a significant impact on the residence as evidenced by a comparison between figure 3 and the remaining fabric that shows that; the original corrugated iron hipped roof and separate concave verandah roof have been altered to a single hipped roof clad with cement tiles. The verandah posts were removed and replaced with slender round steel posts and the timber floor replaced with concrete, as well as the west verandah being removed. The entire exterior of the face brick c.1893 residence and chimney was rendered, as was the c.1952 addition at the time of its construction. On the interior the c.1893 ceilings were replaced with plasterboard ceilings with deco centerpieces and cornices, the walls were textured, the fireplace boarded (cupboard) one side and remodeled on the other side. The doors were all replaced with timber framed glazed doors in keeping with the addition at the rear of the c.1893 residence. The concrete ramped access to the west side door of the c.1893 residence, and the detached laundry building was likely to have been constructed at that time. There is no evidence that any changes took place to Pensioner Guard Cottage although the French doors may have been installed at this time.

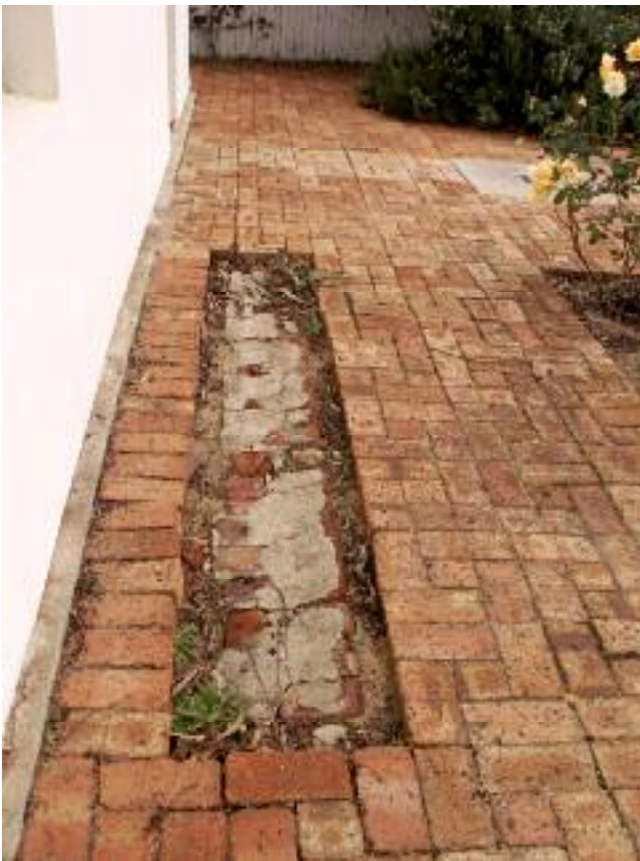
Photo 10 **1 Surrey Street, Bassendean** Drainage detail remnant at the front of Pensioner Guard Cottage. L Gray 7 June 2007

- Undertake site drainage works to ensure there is adequate discharge away from the perimeter of all buildings, and that runoff is away from buildings.
- Instigate immediate action on recommendations pertinent to the long-term viability of the place.
- Ensure that general maintenance is undertaken to a comprehensive schedule on a regular basis.

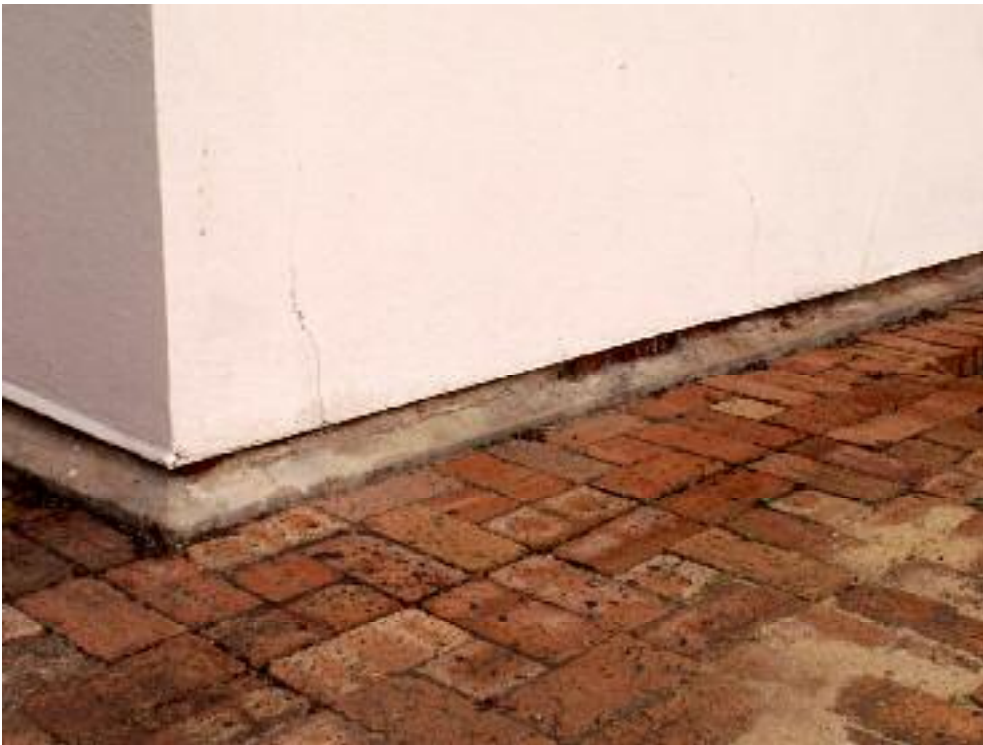
Photo 11 **1 Surrey Street, Bassendean** Edge perimeter detail of Pensioner Guard Cottage, showing cracking of the render. L Gray 7 June 2007

- Monitor cracks that are evident in the walls.
- Restore external walls when cracks have stabilised.
- Reinstall a ledge and brace front door per original.

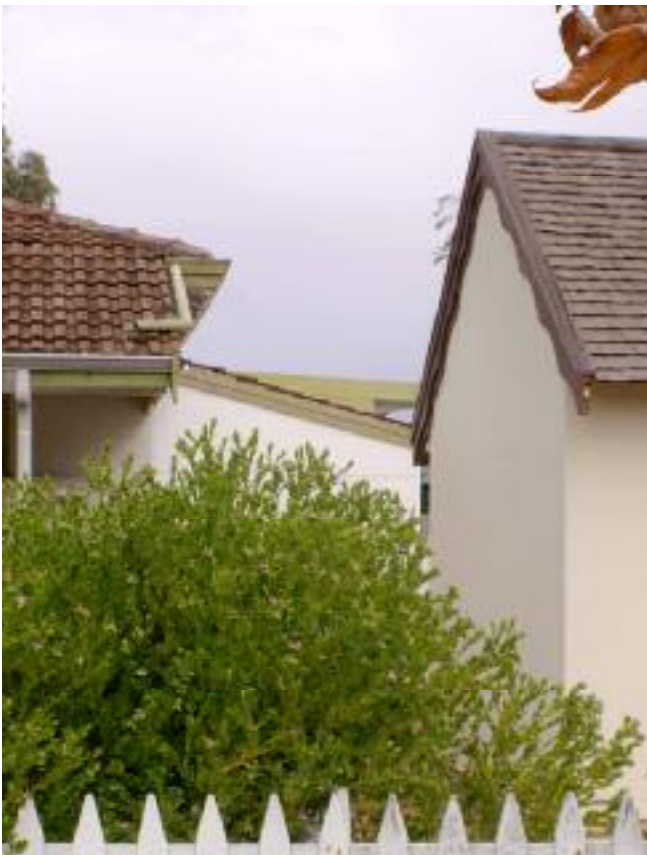
Photo 12 **1 Surrey Street, Bassendean** View looking south showing proximity of the residence, and the east gable wall. L Gray 7 June 2007

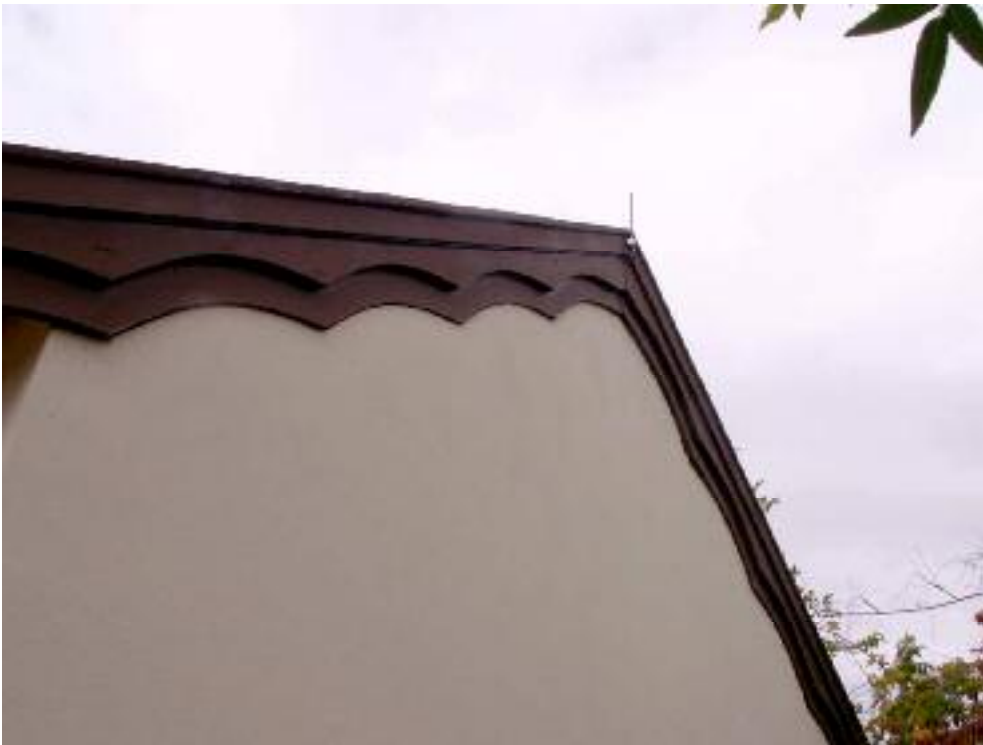
Photo 13 **1 Surrey Street, Bassendean** Detail of the reverse scalloped bargeboards. L Gray 7 June 2007

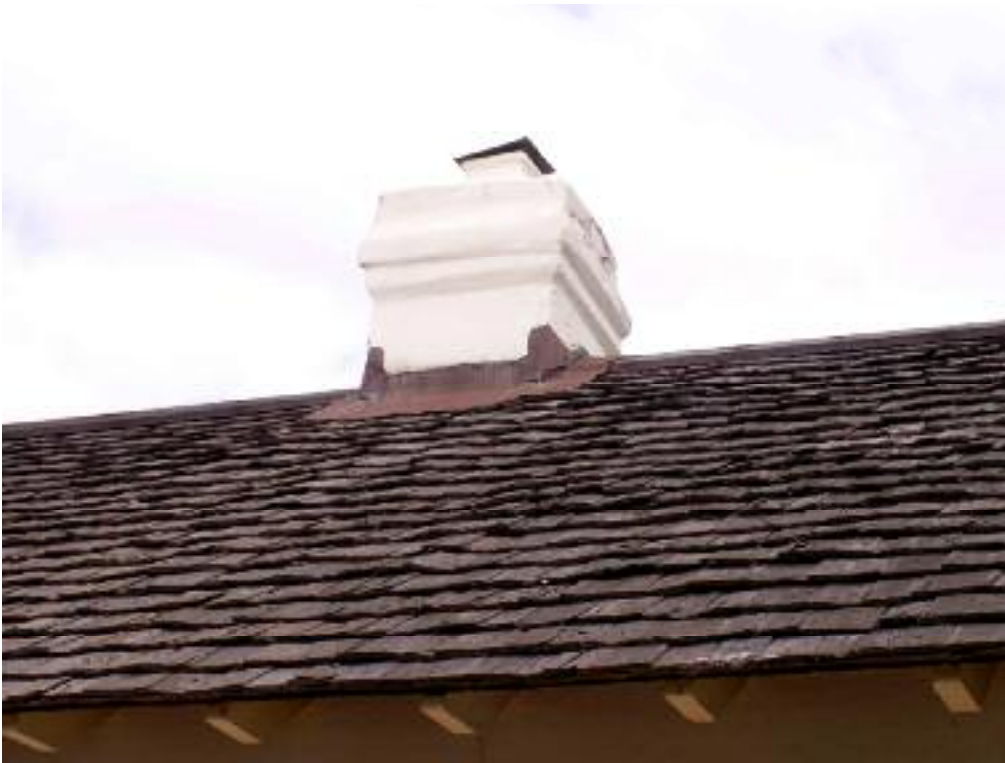
Photo 15 **1 Surrey Street, Bassendean** View of the shingle roof and rendered chimney. L Gray 7 June 2007

- Secure the roof and restore and/or replace any shingles.
- Inspect and monitor the shingle roof situation: Should the roof prove to be inadequate, lay shorts sheets of galvanised iron over the shingles. Retain the shingles insitu to retain the aesthetic of the interior underside of the shingle roof (per original).

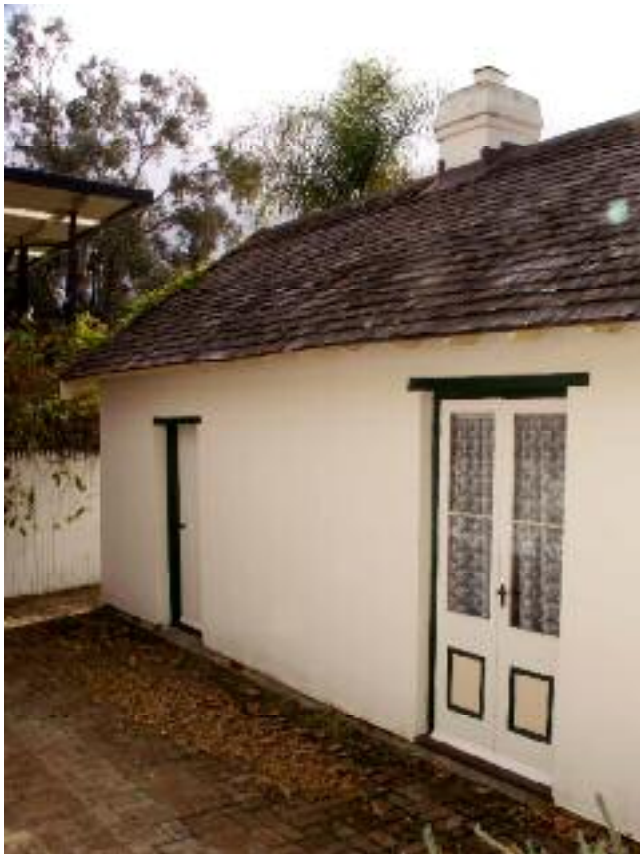
Photo 16 **1 Surrey Street, Bassendean** View looking northwest showing the rear (south) of the Pensioner Guard Cottage, with French doors, and intrusive two storey adjacent residence (left).

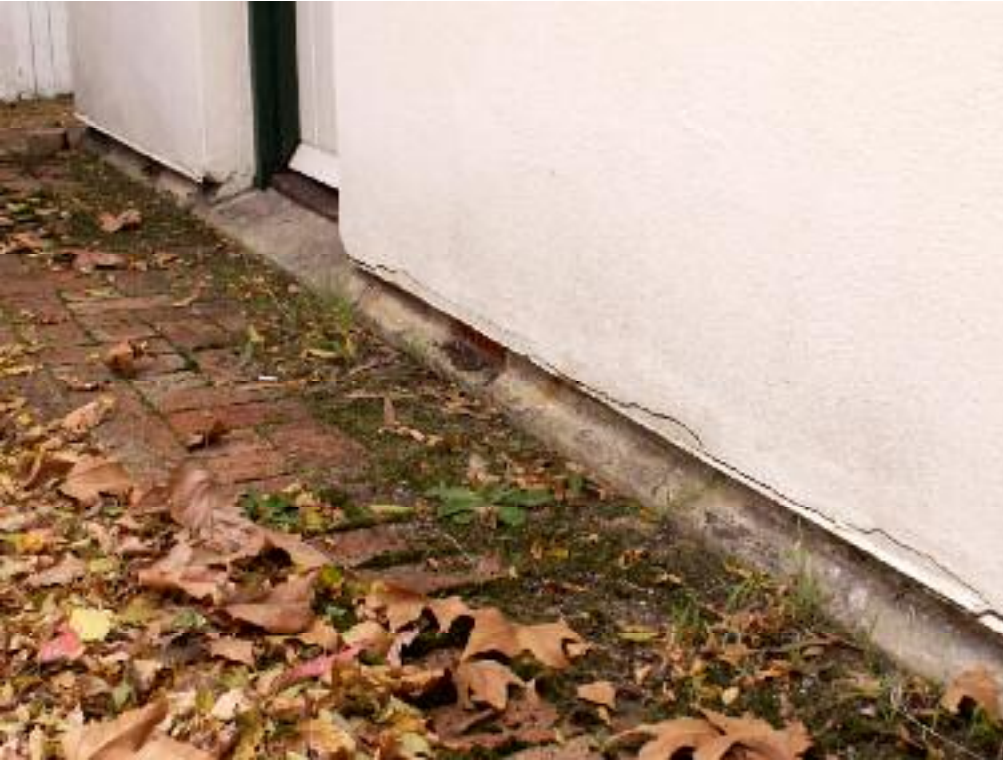
Photo 17 **1 Surrey Street, Bassendean** View of rear wall, showing cracking of render. L Gray 7 June 2007

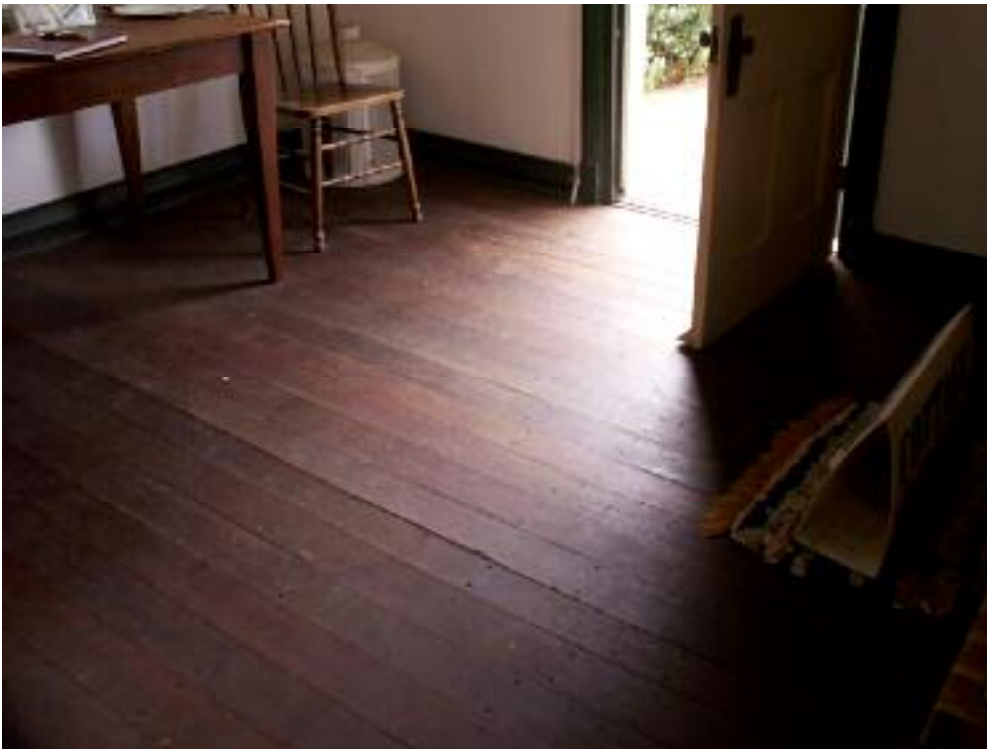
Photo 18 **1 Surrey Street, Bassendean** Interior view showing front entry, floor. L Gray 7 June 2007

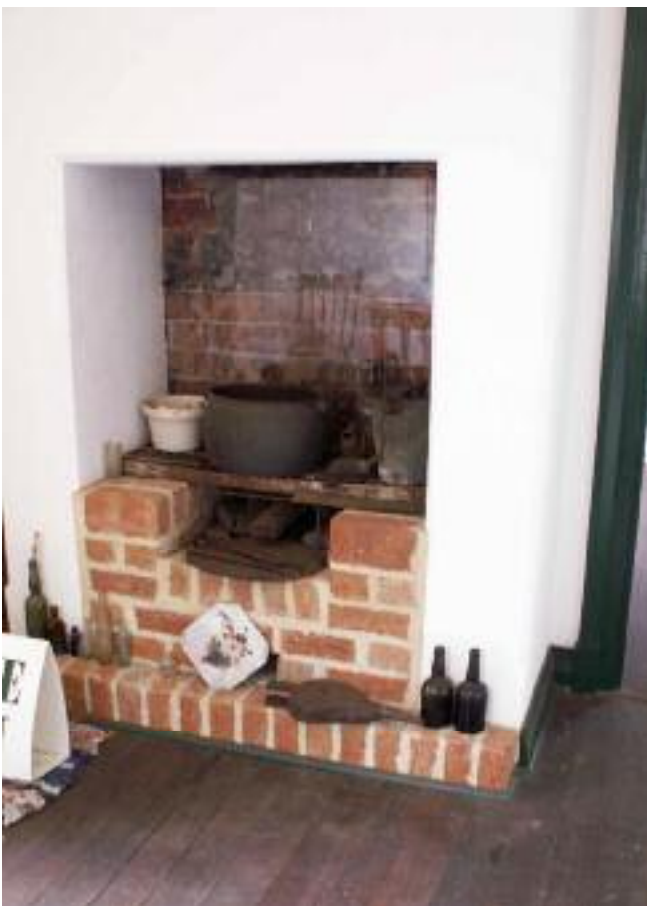
Photo 20 **1 Surrey Street, Bassendean** Interior view showing fireplace in west room. L Gray 7 June 2007

In the early 1990s, there was a significant interest in *1 Surrey Street, Bassendean* after the Town of Bassendean acquired the property in 1988 for a Museum. Several investigations and reports were undertaken, as well as a comprehensive 'conservation' works program to 'restore' the Pensioner Guard Cottage. The research revealed the cultural heritage significance of the place. (Appendix 6), and an archaeological investigation and report revealed minimal evidence (Appendix 7), although, importantly identified that the original floor was brick paved at a lower level than the then existing (and current) floor. However the 1991-1993 works proved to be intrusive to the original fabric that was mostly removed or replaced or altered: the original shingles and corrugated iron over, were removed and shingles replaced; the lime washed roof structure that formed the interior ceiling was replaced with new timbers; the replacement timber floors were removed and replaced again; the windows were removed and reconstructed, not to the existing photographic evidence (figure 1); doors were replaced; the exterior walls were rendered; the fireplace was reconstructed, retaining only the back firewall; and, the south verandah was demolished.

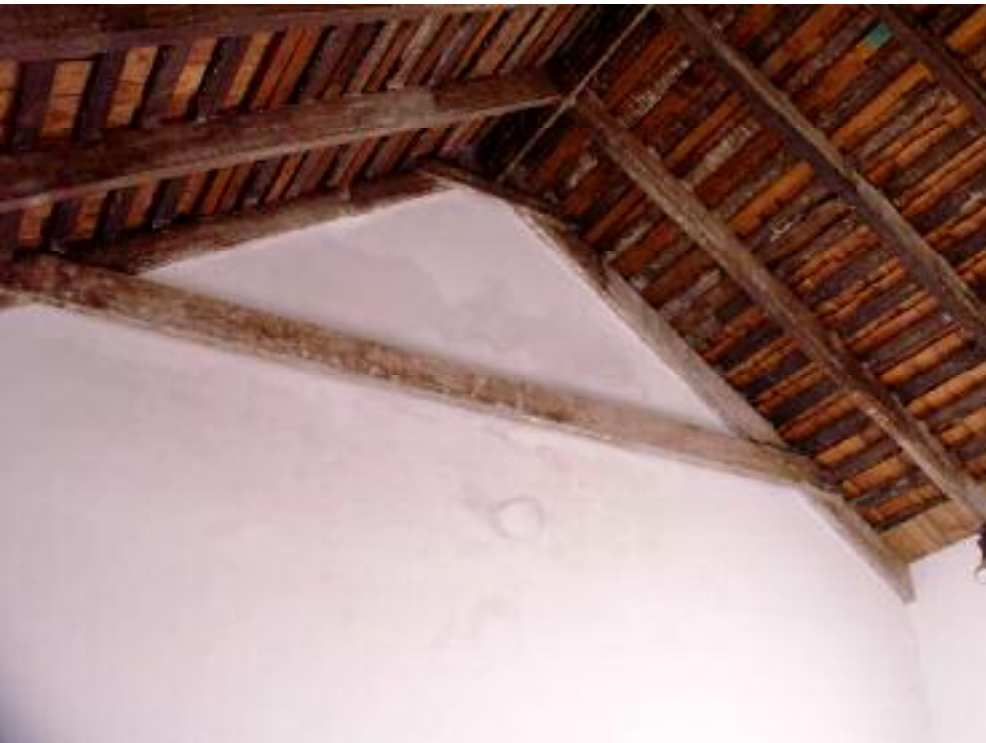
Photo 24 **1 Surrey Street, Bassendean** Interior view showing the original timber structure that formed the ceiling, with remnants of limewash evident on the timber. L Gray 7 June 2007

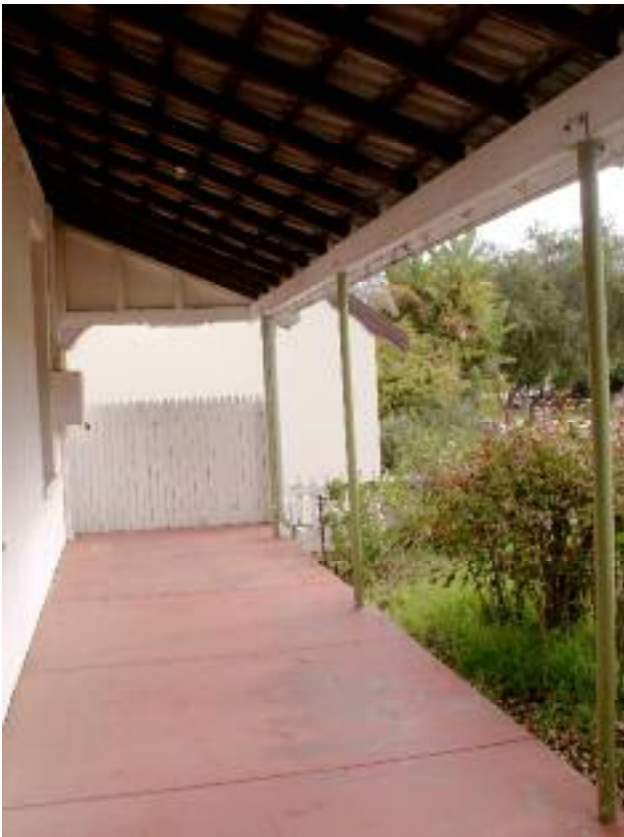
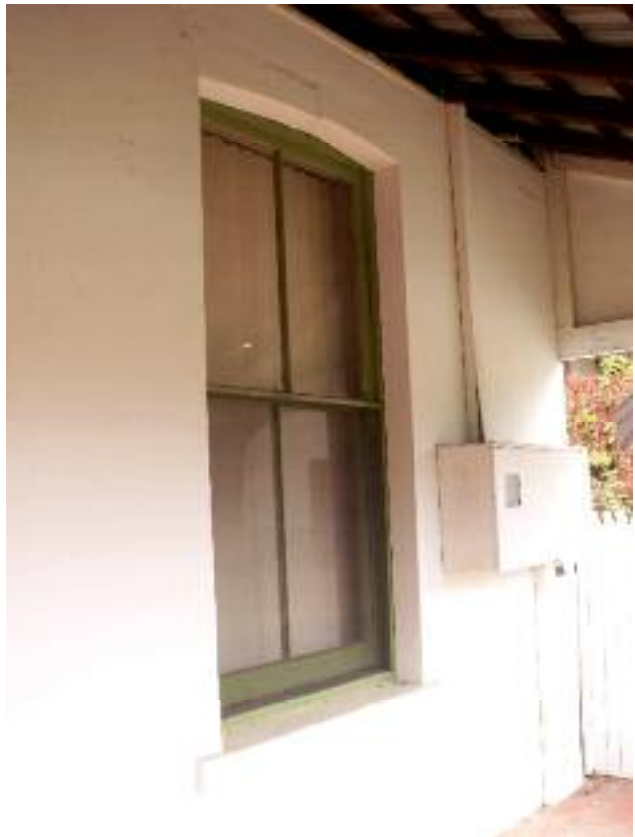
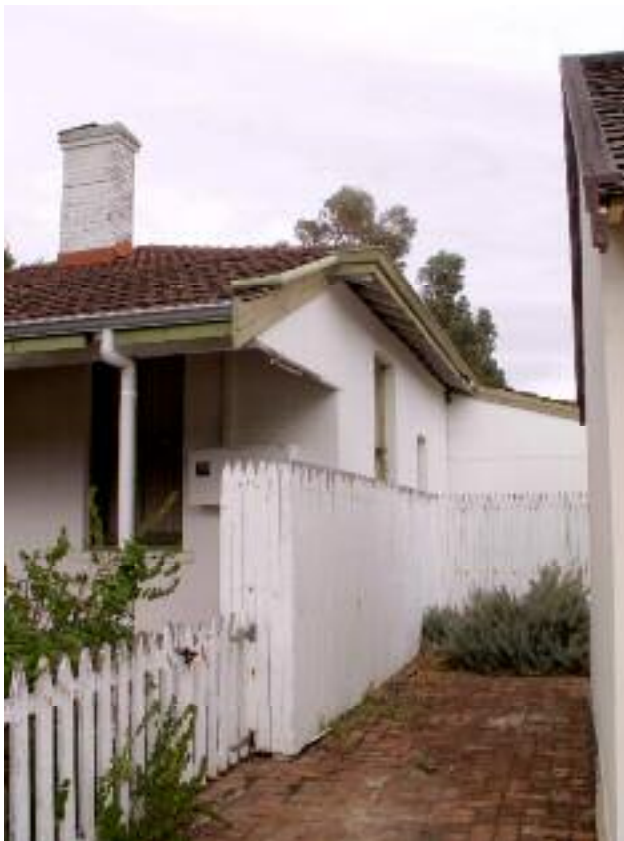
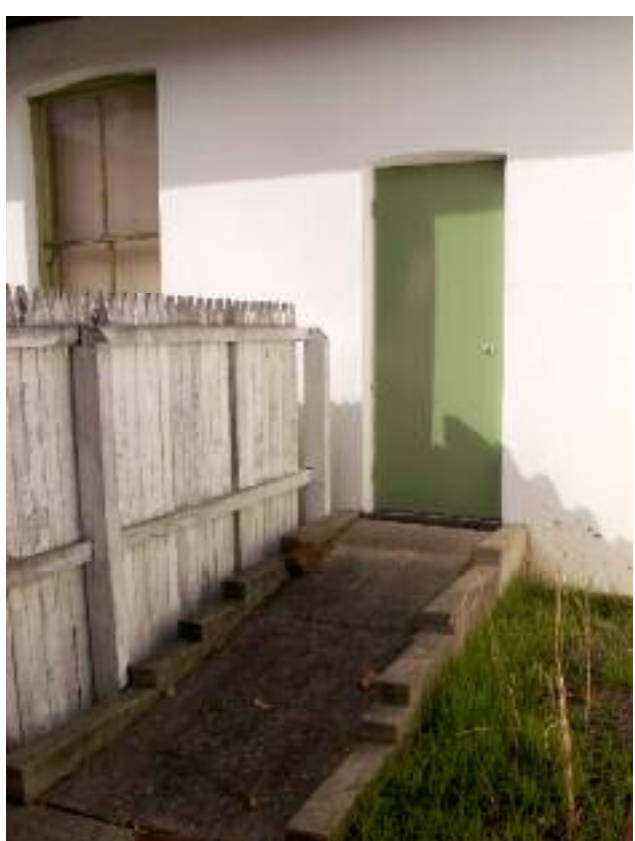
Photos 27-30 **1 Surrey Street, Bassendean** c.1893 residence showing front veranda; window c.1893 (typ); proximity on northwest corner; and, west connection from the rear of Pensioner Guard Cottage. L Gray 7 June 2007

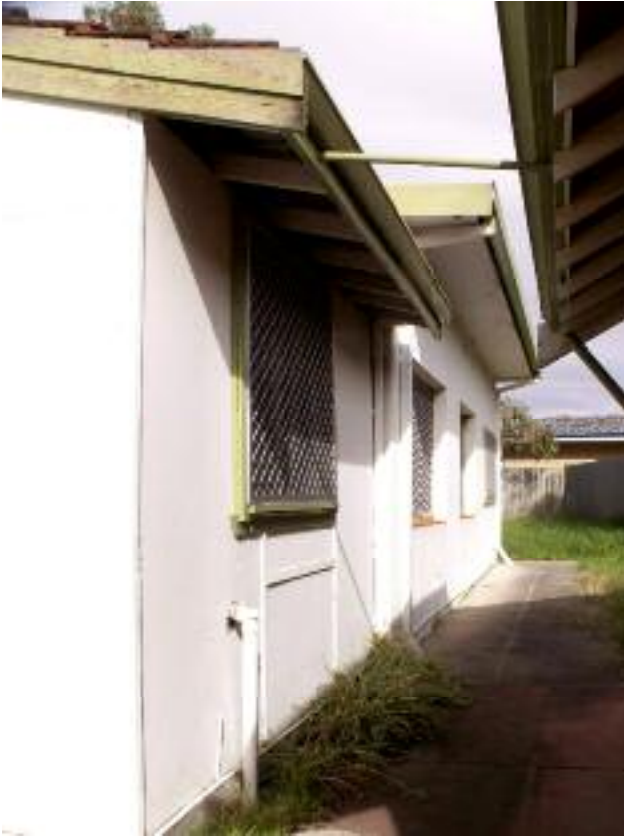
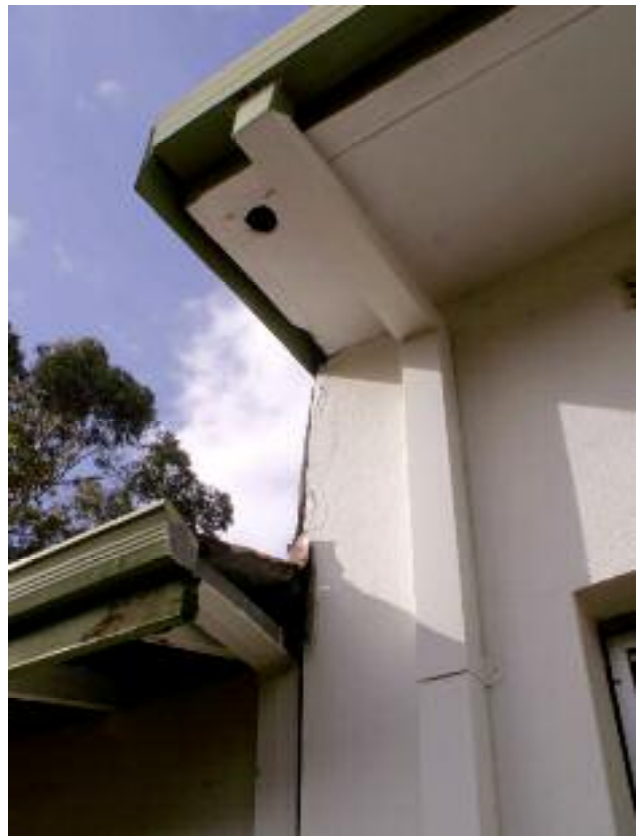
Photos 31, 32 **1 Surrey Street, Bassendean** View looking south along the west side from northwest verandah enclosure of c.1893 residence, showing proximity of laundry (eaves-right); roof connection detail between northwest verandah enclosure of c.1893 residence and the c.1952 extension on west side. L Gray 7 June 2007

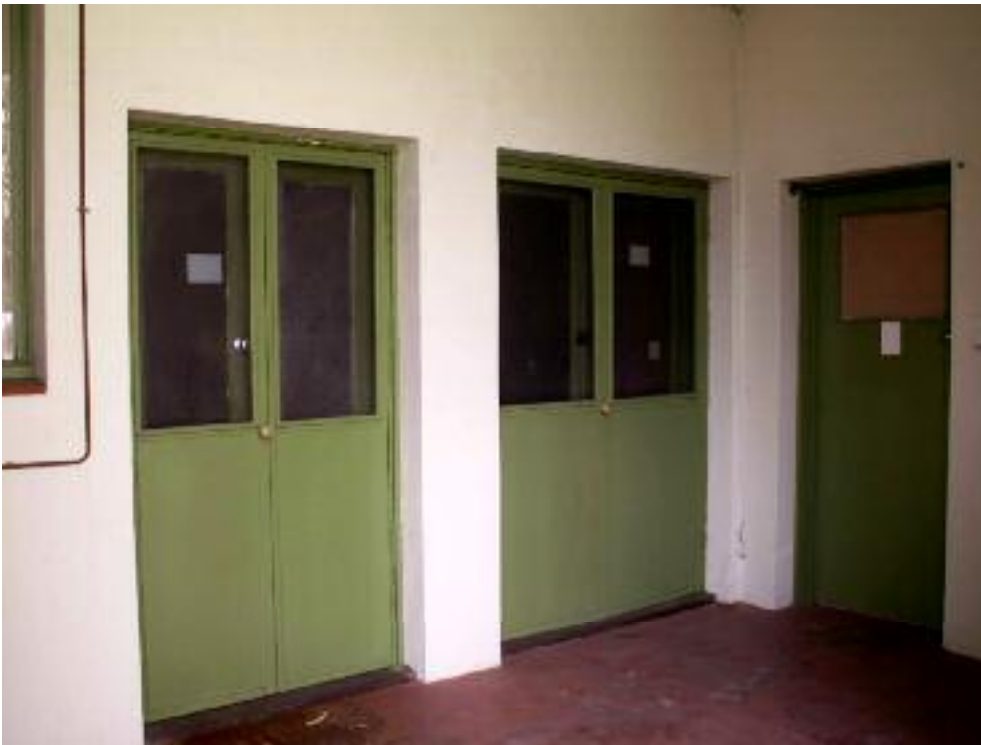
Photo 34 **1 Surrey Street, Bassendean** View of rear verandah of c.1952 addition, showing (l-r) doors to kitchen east room and bathroom. L Gray 7 June 2007

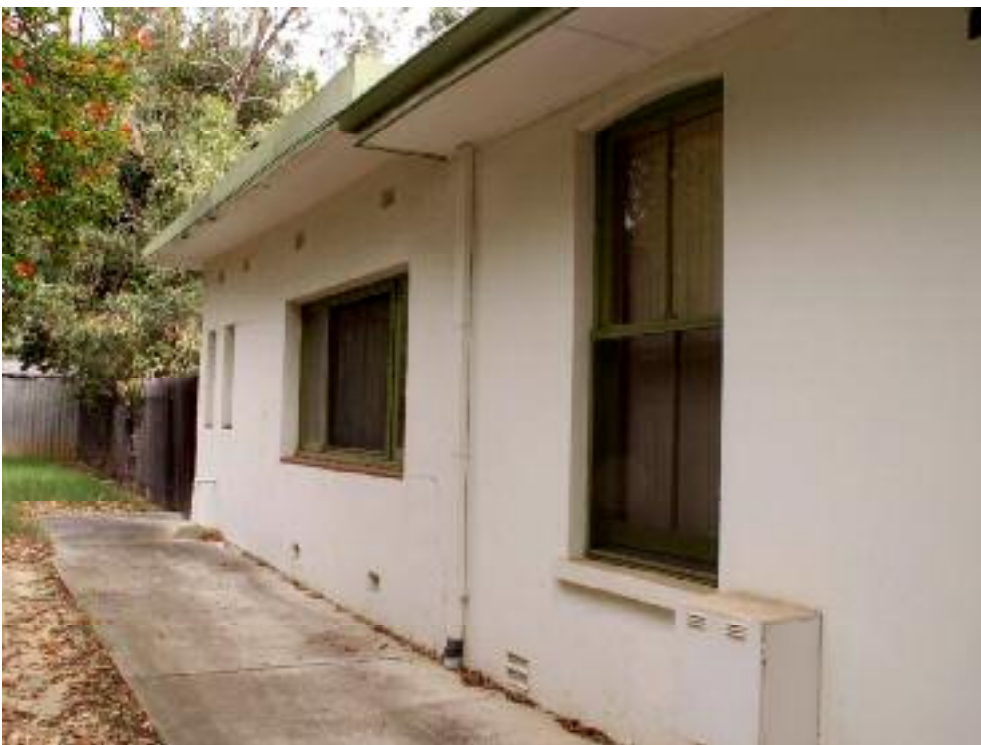
Photo 35 **1 Surrey Street, Bassendean** View looking south along the east side of c.1893 residence showing the c.1952 additions connection. L Gray 7 June 2007

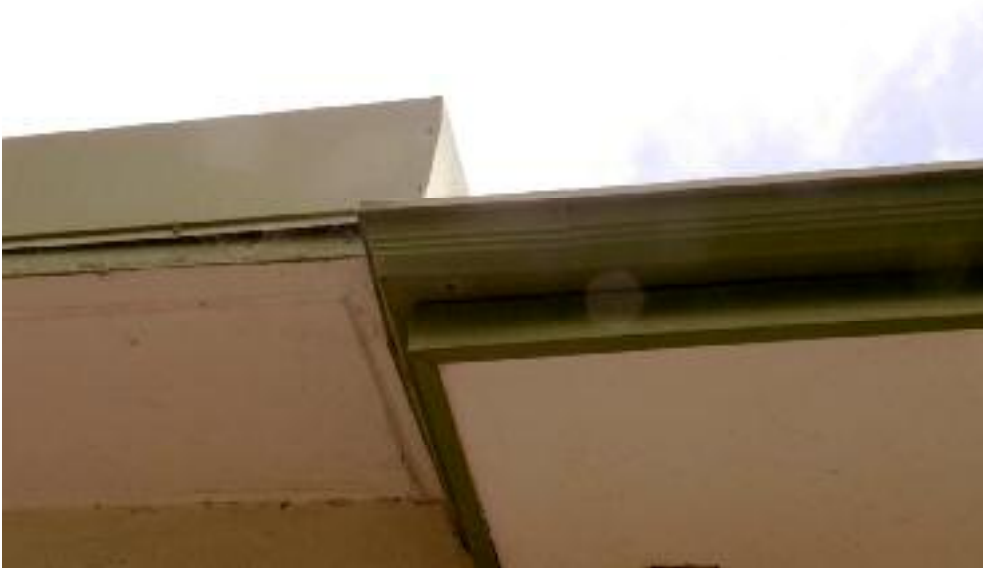
Photo 36 **1 Surrey Street, Bassendean** Roof connection on east side between c.1952 additions (left) and c.1893 roof. L Gray 7 June 2007

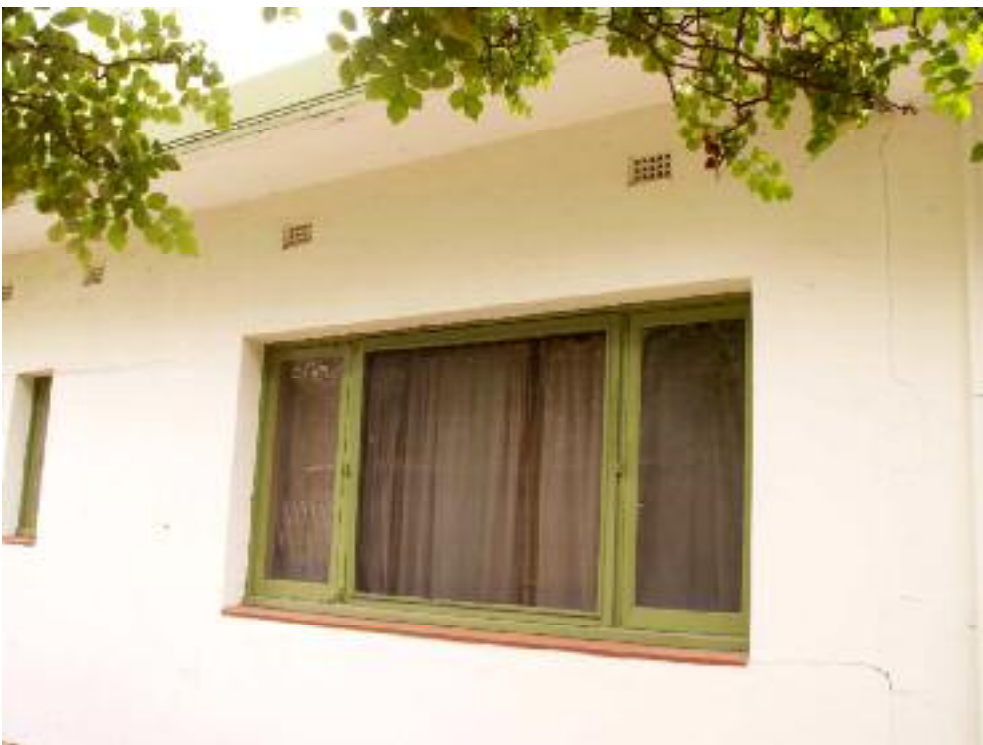
Photo 37 **1 Surrey Street, Bassendean** A window (typ) of the c.1952 additions connection. L Gray 7 June 2007

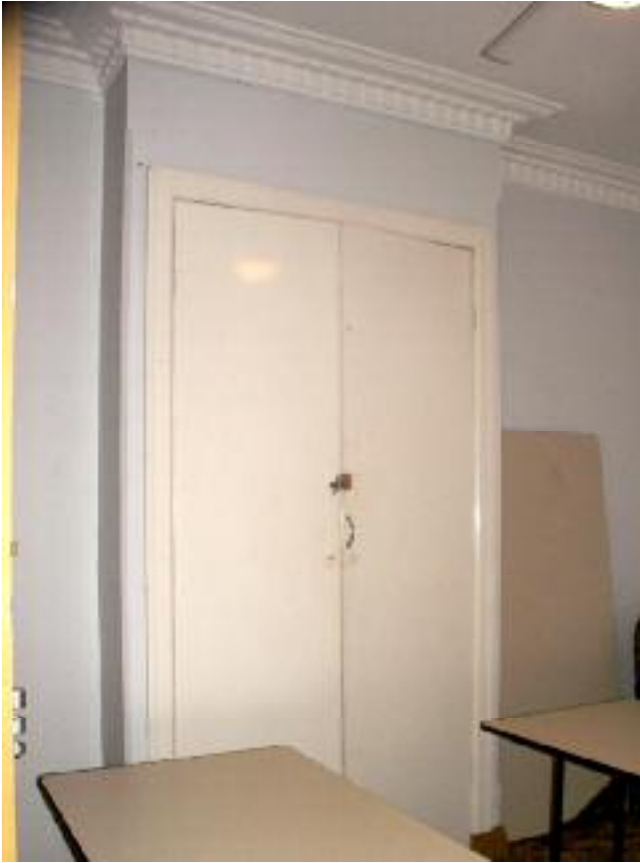
Photo 42 **1 Surrey Street, Bassendean** c.1893 residence: Interior view of cupboard enclosed fireplace in the northeast front room. L Gray 7 June 2007

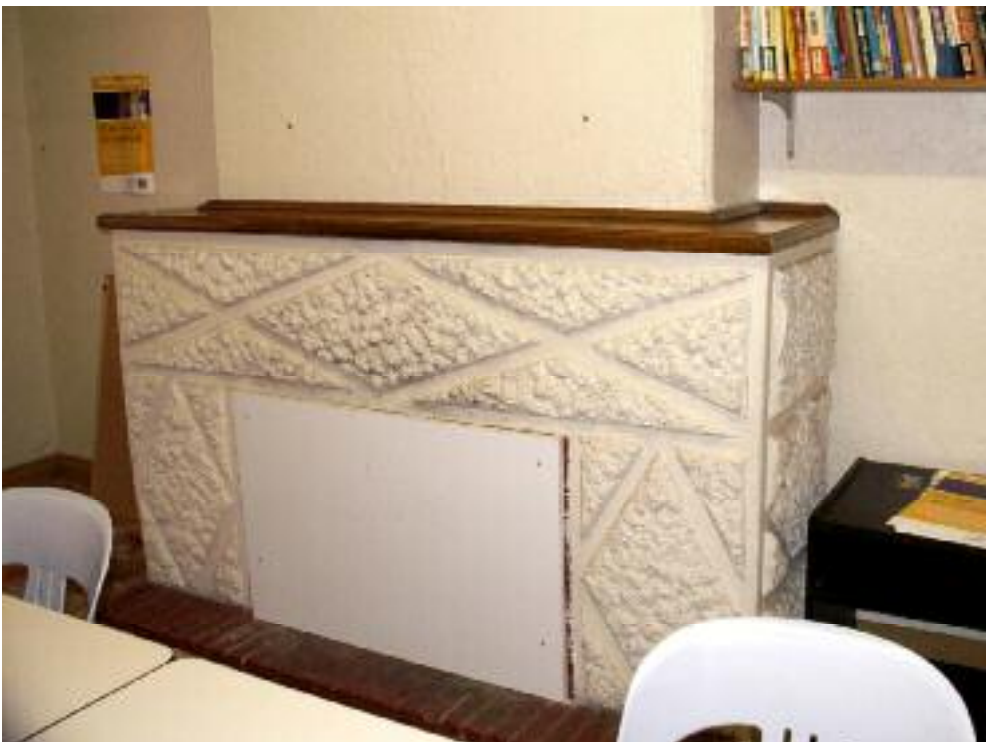
Photo 43 **1 Surrey Street, Bassendean** c.1893 residence: Interior view of the back-to back fireplace with the c.1952 renovation. L Gray 7 June 2007

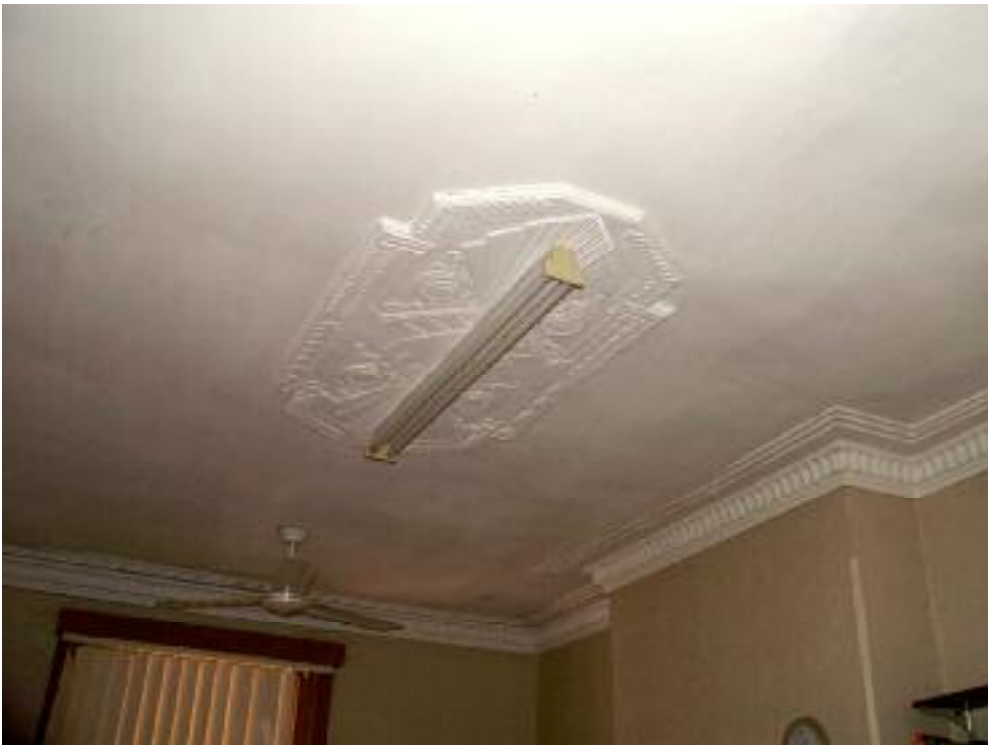
| Ceilings | <p>The ceilings are c.1952 plasterboard with art deco centerpieces and simple geometric style cornices. The ceiling of the roof opening off the kitchen has replacement suspended panels with pvc battens.</p> <p><u>Condition</u> The ceilings are in fair condition with evidence of moisture ingress throughout, with a large section of damaged ceiling in the northwest verandah enclosure.</p> |

Photo 44 **1 Surrey Street, Bassendean** c.1893 residence: Interior view of c.1952 ceiling of the northwest front room. L Gray 7 June 2007

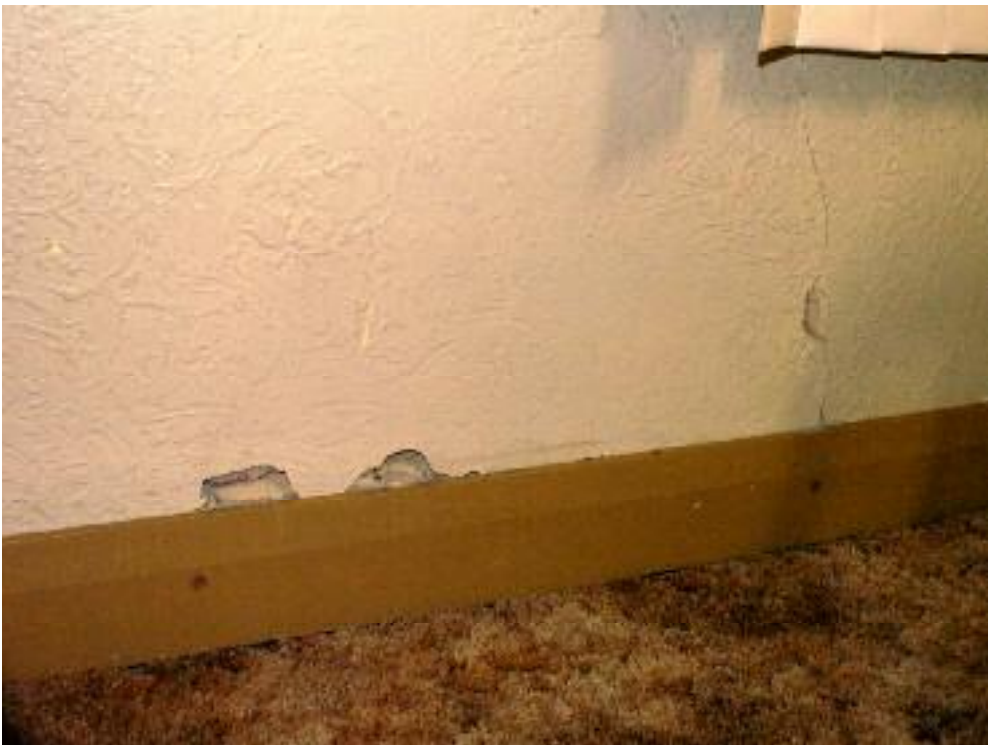
Photo 45 **1 Surrey Street, Bassendean** c.1893 residence: damage on the north wall of the northwest front room. L Gray 7 June 2007

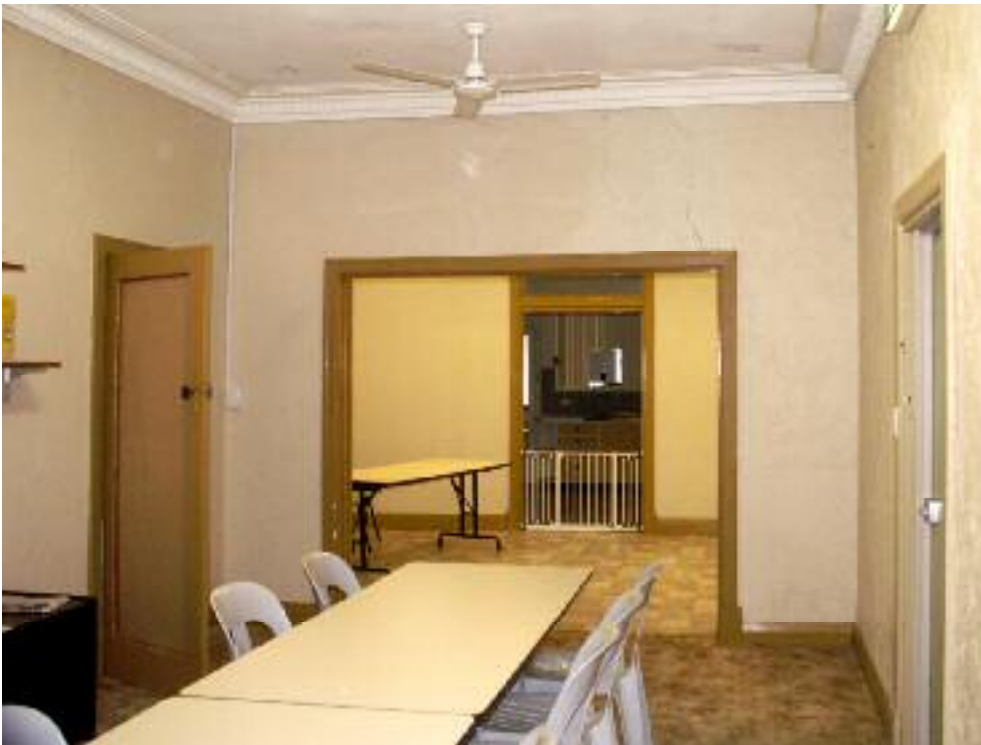
Photo 46 **1 Surrey Street, Bassendean** c.1893 residence: Interior view looking from northwest front room to the rear (kitchen): left door to entry corridor; right door to exterior west connection to Pensioner Guard Cottage.

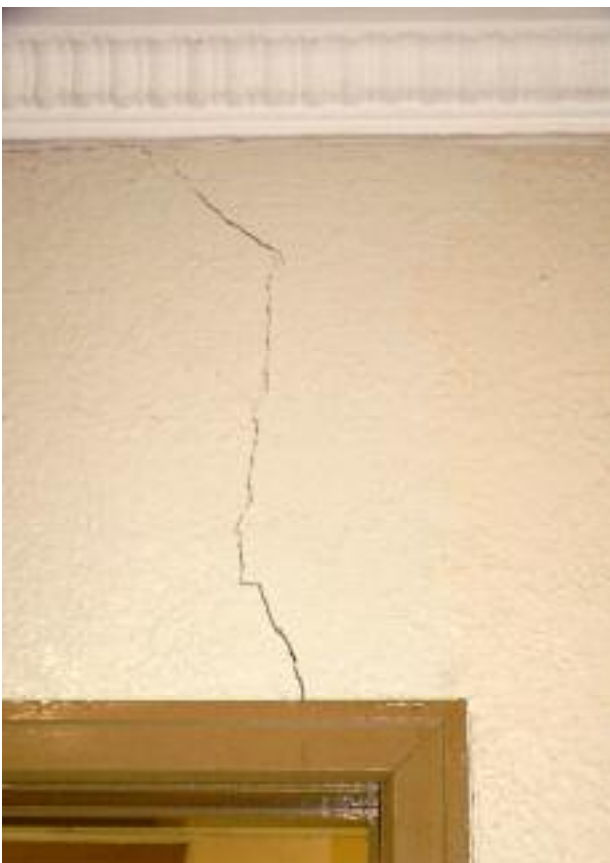
Photos 47, 48 **1 Surrey Street, Bassendean** c.1893 residence: wall per photo 46; kitchen doors. L Gray 7 June 2007

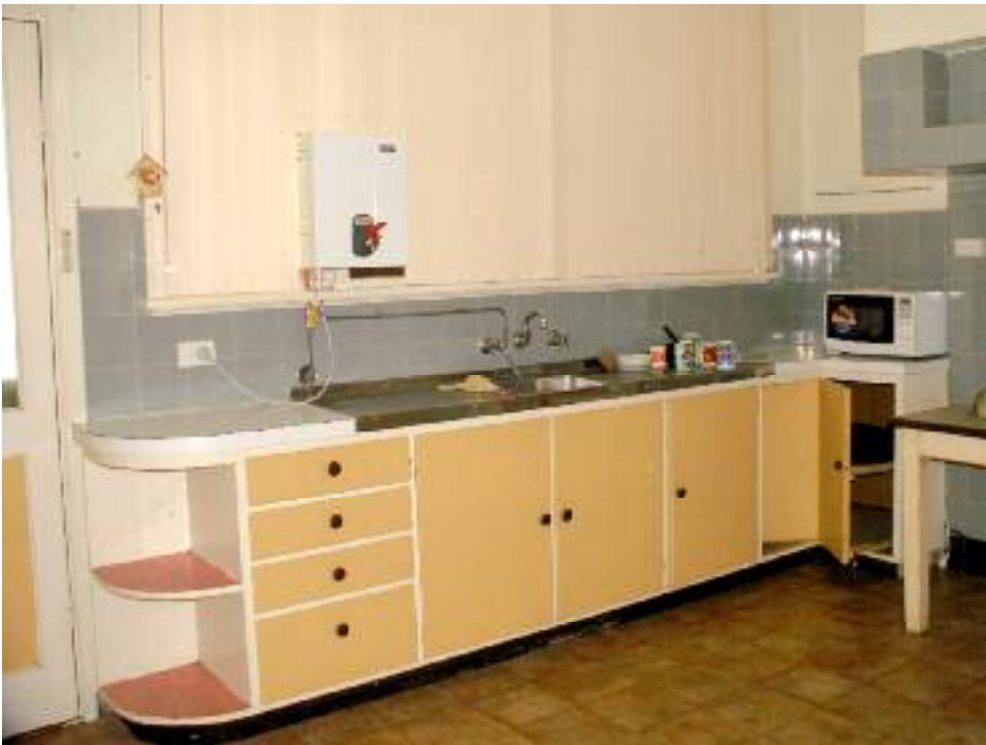
Photo 49 **1 Surrey Street, Bassendean** c.1952 addition: rear wall of kitchen, showing original fitout.
L Gray 7 June 2007

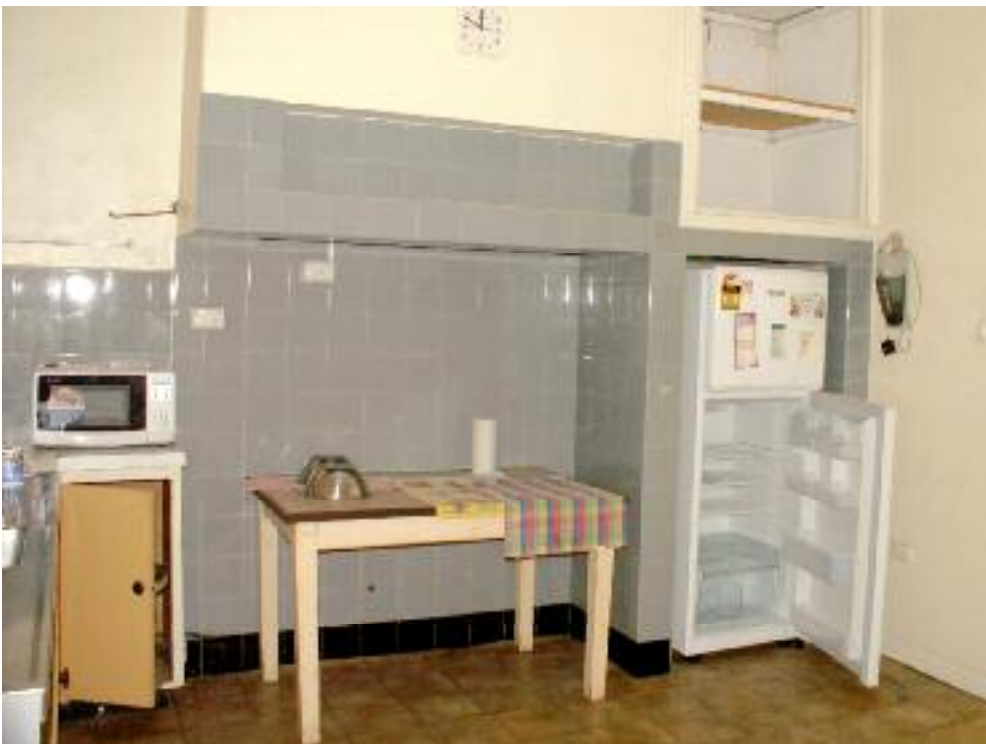
Photo 50 **1 Surrey Street, Bassendean** c.1952 addition: west wall of kitchen, showing original tiled recess.
L Gray 7 June 2007

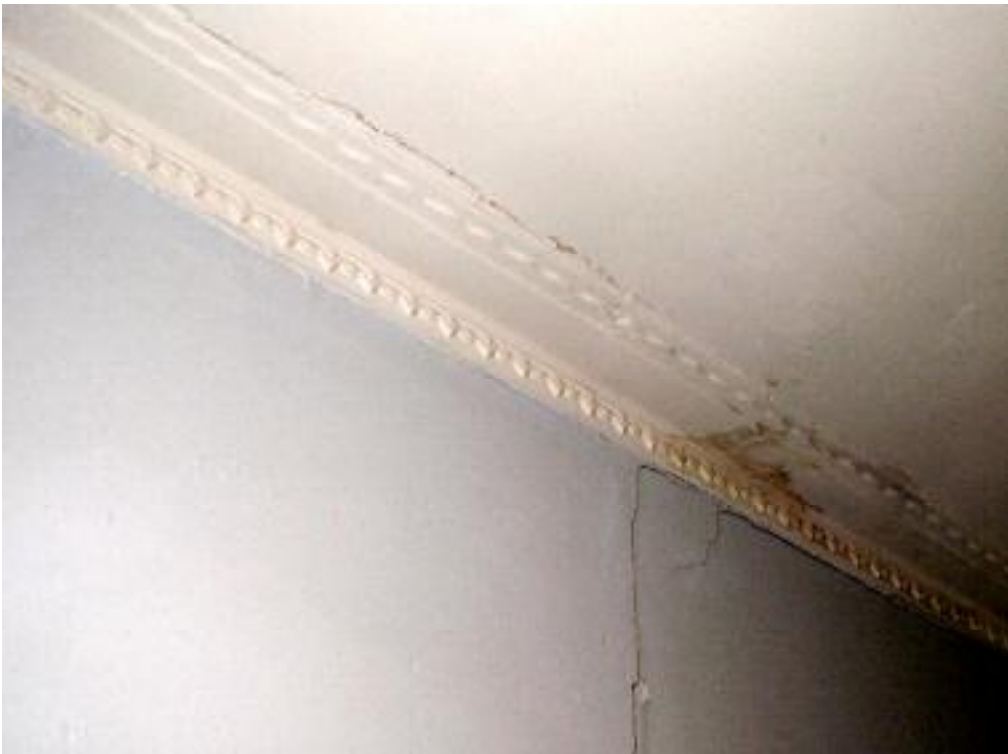
Photo 51 **1 Surrey Street, Bassendean** c.1952 addition: damaged ceiling and cracked wall. L Gray 7 June 2007

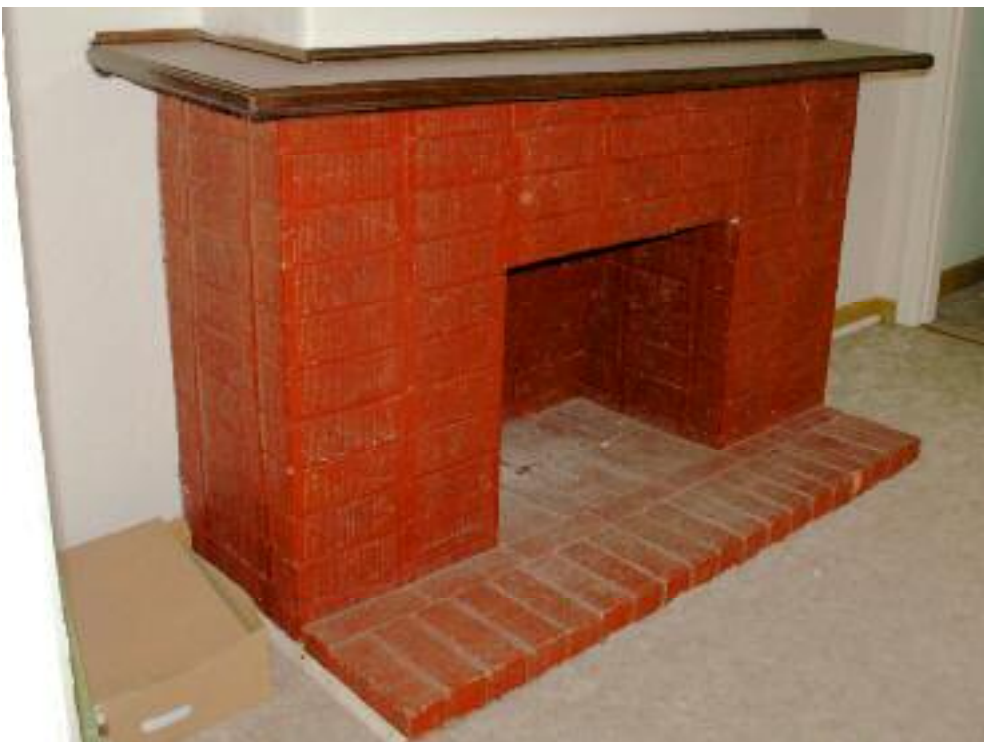
Photo 52 **1 Surrey Street, Bassendean** c.1952 addition: west room showing fireplace. L Gray 7 June 2007
