1 SURREY STREET, BASSENDEAN

Pensioner Guard Cottage (1856-1857, 1991-1993)

Residence (c.1893, c.1952)

CONSERVATION MANAGEMENT PLAN

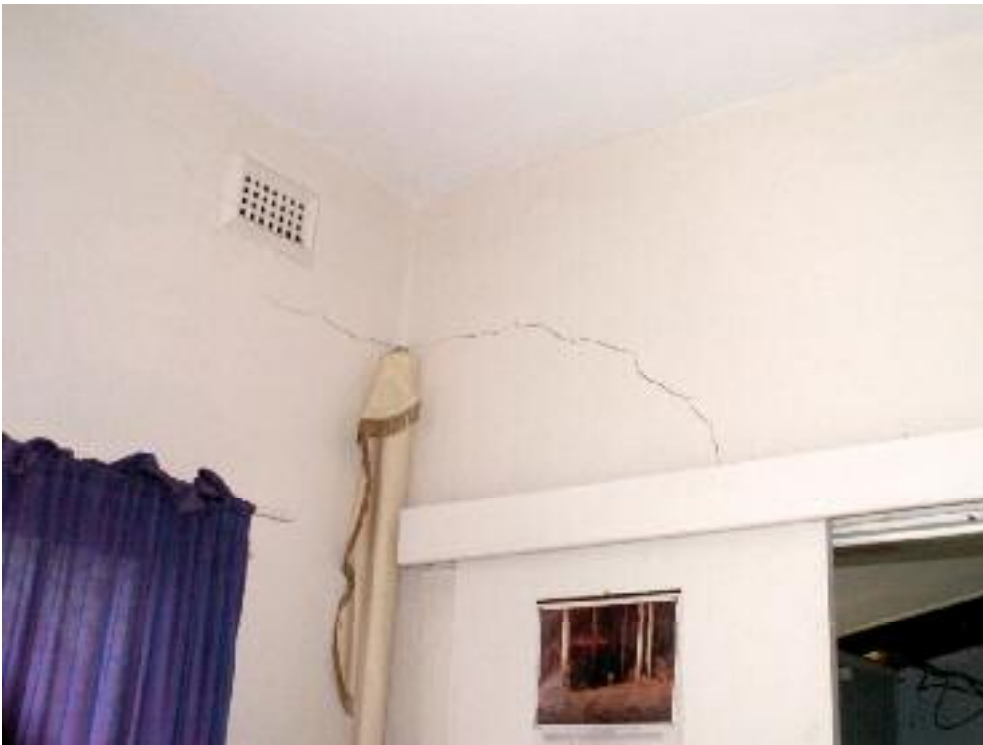
Photo 53 **1 Surrey Street, Bassendean** c.1952 addition: west room showing wall damage at connection to the c.1893 northwest verandah room. L Gray 7 June 2007

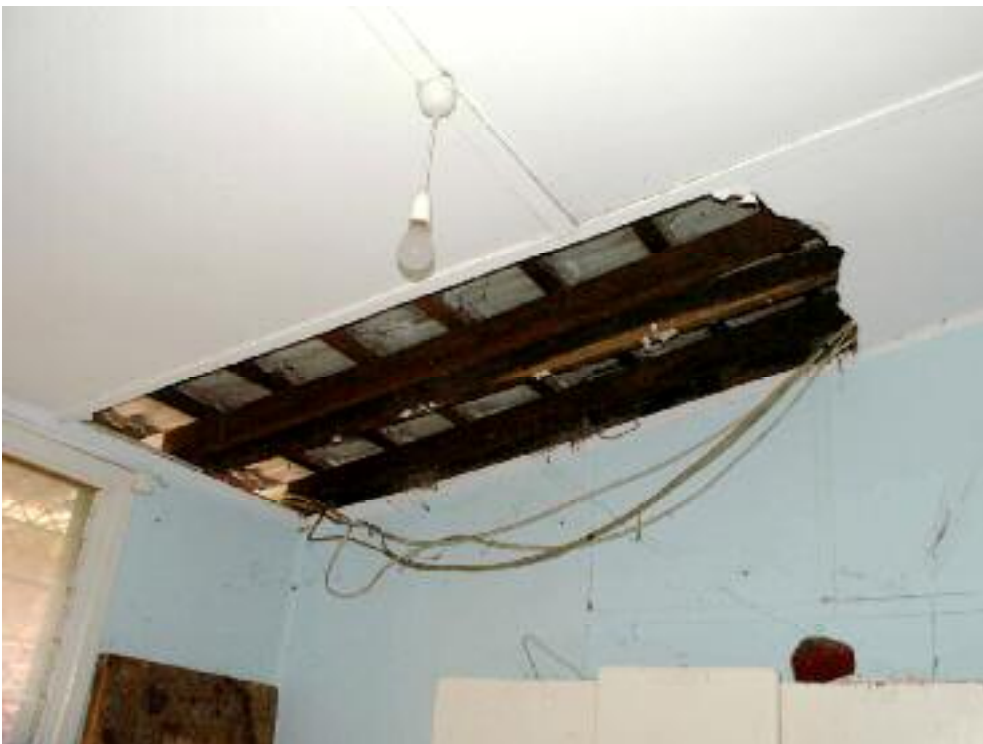
Photo 54 **1 Surrey Street, Bassendean** c.1893 northwest verandah room showing ceiling damage. L Gray 7 June 2007

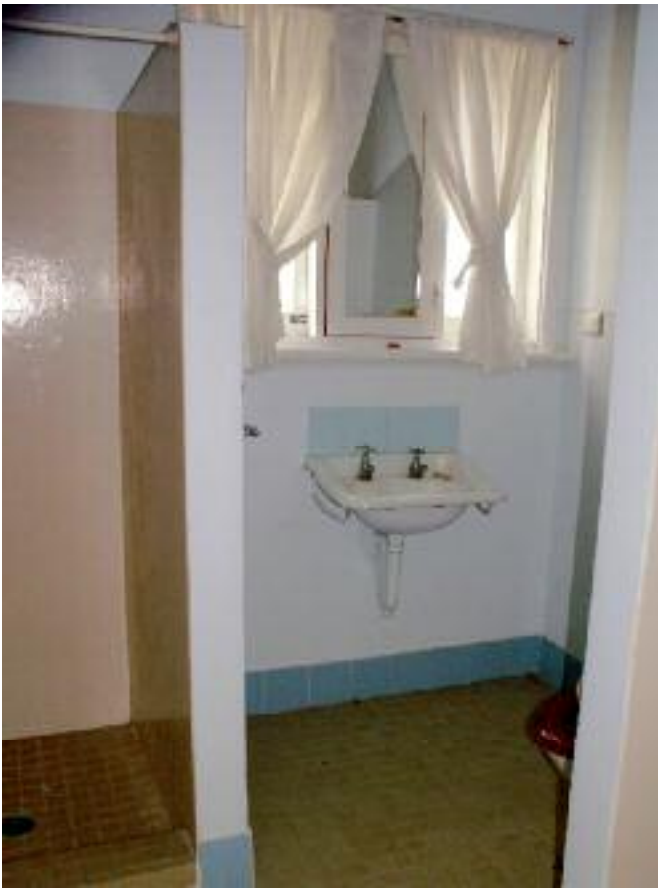
Photo 55 **1 Surrey Street, Bassendean** c.1952 addition: bathroom at east end of rear verandah. L Gray 7 June 2007

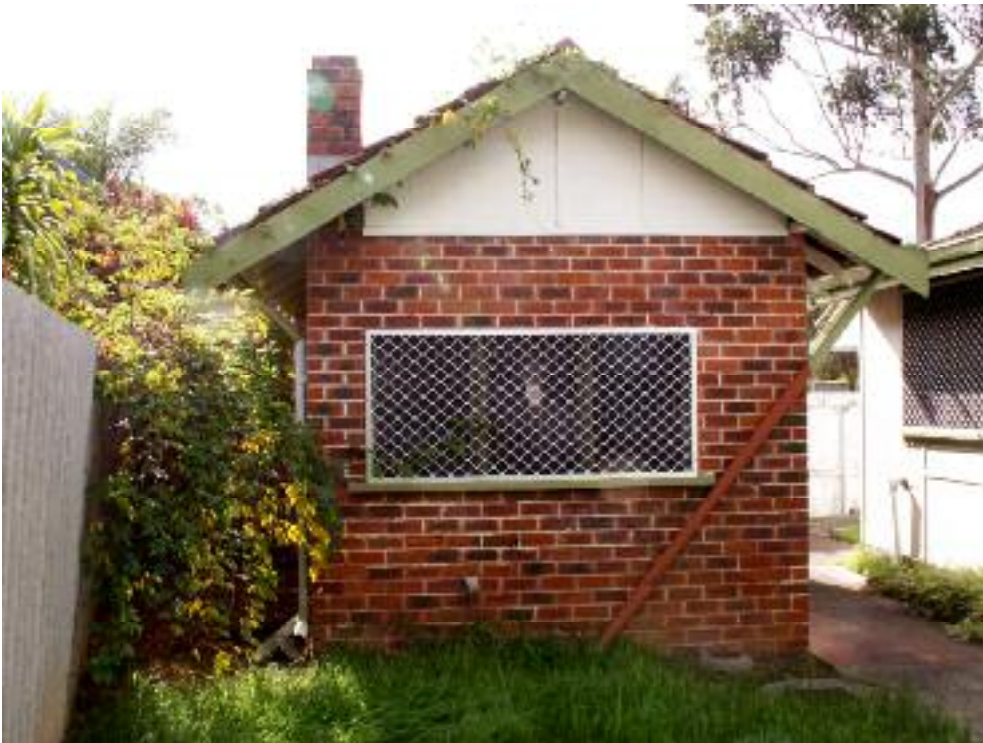
| Outbuilding | <p>On the west side of the residence, behind (south) of the Pensioner Guard Cottage, is a two room rectangular form face brick laundry building with a gable tiled roof. The bricks are tapestry face bricks laid in stretcher bond. The roof is tiled as for the front section of the residence, in cement tiles. The windows are louvered, and the door is a timber lined ledge and brace door. No interior inspection was undertaken.</p> <p><u>Condition</u> The external timber elements are significantly weathered revealing bare timber throughout. There is evidence of weathered bricks and some fretted mortar, and an extensive area on the east wall shows evidence of previous mortar replacement.</p> |

Photo 56 **1 Surrey Street, Bassendean** c.1952 laundry: south elevation. L Gray 7 June 2007

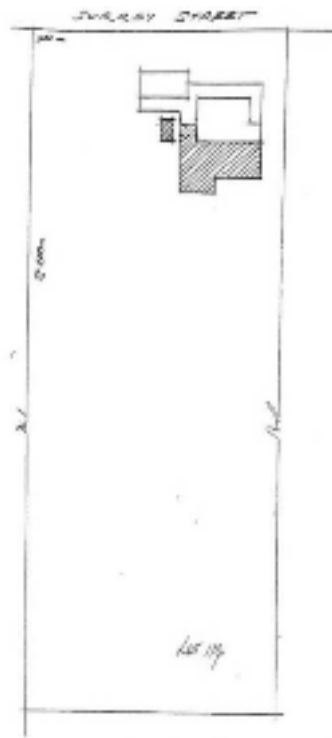
c.1952 Extension at rear of c.1893 residence and freestanding ablutions (west side)
Renovations to c.1893 residence.
Likely some alterations to Pensioner Guard Cottage: verandah, French doors
